CAR DETAILS			
Car Manufacturer	Maruti Suzuki	Power Steering	Yes
Model	Ciaz	Shape	
Variant	ZXi	Insurance Type	Comprehensive
Registration no	MH03BSXXXX	Insurance Expiry	22-Jul-2023
City	Mumbai	Number of Owners	1
Fuel type	Petrol	Manufacturing Year	2014
Transmission	Manual	Date of Registration	03-Nov-2014
KM Run (as seen)	63,258 Kms	RTO Location	Mumbai
Colour	White	Hypothecation	No

CTE/EVALUATION ID/1984199, EVALUATION DATE:07/06/2023

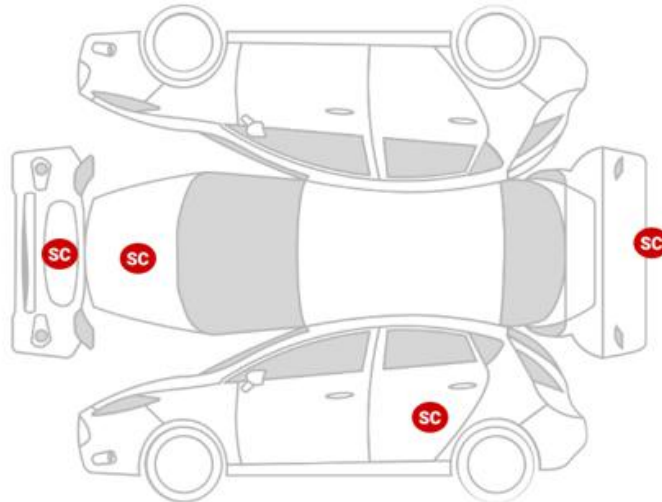
CAR BODY	MINOR WORK NEEDED	HEADLIGHTS	WORKING
✗ Minor dents and scratches		✓ Main bulb working (dipper)	✓ Parking bulb working
WIPERS	WORKING	INSIDE & OUTSIDE REAR VIEW MIRRORS	WORKING
✓ Wiper blades are ok	✓ Wiper motor is working fine	✓ Mirror and casing OK	✓ Electric folding functional
		✓ Adjustment lever functioning ok	
TURN INDICATORS	WORKING	TAIL LIGHTS	WORKING
✓ Side indicator light working		✓ Main bulb working	✓ Parking bulb working
		✓ Reverse indicator bulb working

Refurb Name	Estimated Cost	Remarks
Suspension Noise While Driving - Front	7000	Both shock absorber need to replace
N/A	5000	Service Required
Oil	2000	Engine oil need to replace
Car Body	10000	4 panels painting required
Brake Assembly	1500	Breke need to cleaning
Total	25500/-
